**Subject: Clean Air Act Accident Inspection Report, Revision 01
Big Ox Energy – Siouxland, LLC
1616 D. Avenue, Dakota City, Nebraska 68731
U.S. EPA Region 7 START 4, Contract No. EP-S7-13-06, Task Order No. 0028
Task Monitor: Elizabeth Koesterer**

CAA112(r) INSPECTION REPORT

Name: Big Ox Energy – Siouxland, LLC	
Address: 1616 D Avenue, Dakota City, NE 68731	Date of Inspection: November 13-14, 2018
County: Dakota	Case No: 18NE1113
Phone: 844-491-1953	RMP No: N/A
High Risk: No	FRS No: 1100 6458 7656
CAA Title V: No (NDEQ CP15-033)	Program Level: General Duty Clause
Mailing Address: 6601 County Road R, Denmark, WI 54208	
Process: Biogas production from anaerobic digestion of wastewater from multiple sources. NAICS: 325199 – All other basic organic chemical manufacturing

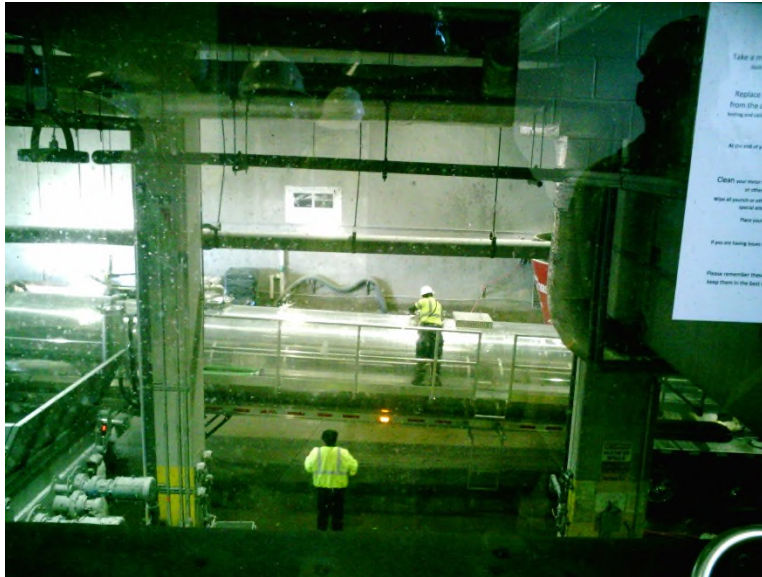
From the overlooking observation room, we observed receiving bay operations as a tanker truck arrived and unloaded material to the receiving pit (see Attachment 3, Photograph 1). The receiving bay entry door to the outside was left open during the unloading operation. We observed that the receiving bay is connected to the warehouse area by one bay door and one pedestrian door; both were closed during the unloading operation that we observed.

As we watched the truck being unloaded, we observed a Big Ox employee open a hatch on top of the tank trailer, after which the back main valve of the tank trailer was opened, and high-strength waste emptied from the truck and flowed past a floor grate and into a sub-floor receiving pit. An employee collected a grab sample from the flowing material by use of a cup fixed to an extension handle. We did not observe any employees involved in the truck unloading wearing respiratory protection; however, they were wearing personal four-gas monitors.

<p>CASE NO. 18NE1113</p> <p>Direction: North</p>	DESCRIPTION	This photograph shows unloading of hauled-in, high-strength waste in the receiving bay. A worker is opening the top hatch of the trailer tank.	1
	FACILITY	Big Ox Energy - Siouxland, LLC	Date
	PHOTOGRAPHER	Dave Hensley	11/13/2018

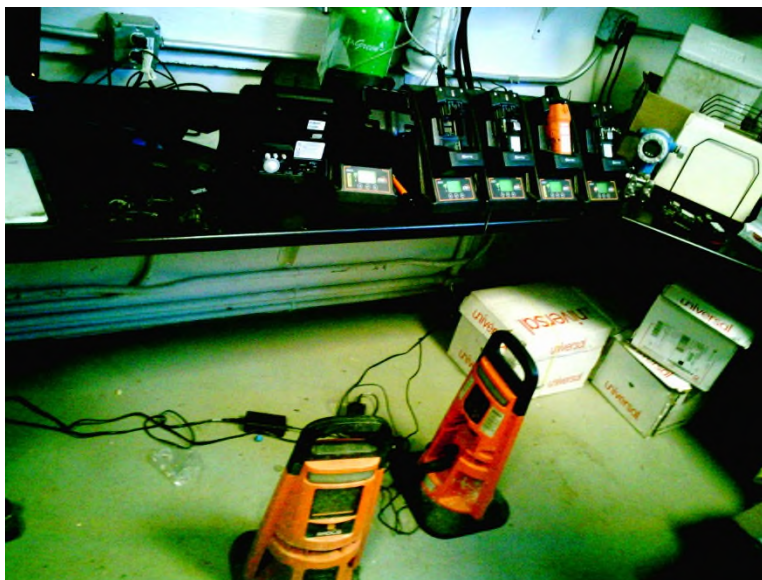
In the receiving bay observation room/office, we observed Industrial Scientific RADIUS-BZ1 gas monitor docking stations, calibration gases, and extra RADIUS-BZ1 monitors (see Attachment 3, Photograph 2). Mr. Hensley asked how often the monitors are calibrated. Ms. McCaslen told us calibration occurs each time the monitors are brought into the office for recharging. Mr. Hensley asked about negative readings among monitoring data he had observed. Ms. McCaslen said she was not sure what had caused the negative readings.

<p>CASE NO. 18NE1113</p> <p>Direction: N/A</p>	DESCRIPTION	This photograph shows Industrial Scientific RADIUS-BZ1 gas monitors being charged in the receiving bay observation room/office.	2
	FACILITY	Big Ox Energy - Siouxland, LLC	Date
	PHOTOGRAPHER	Dave Hensley	11/13/2018

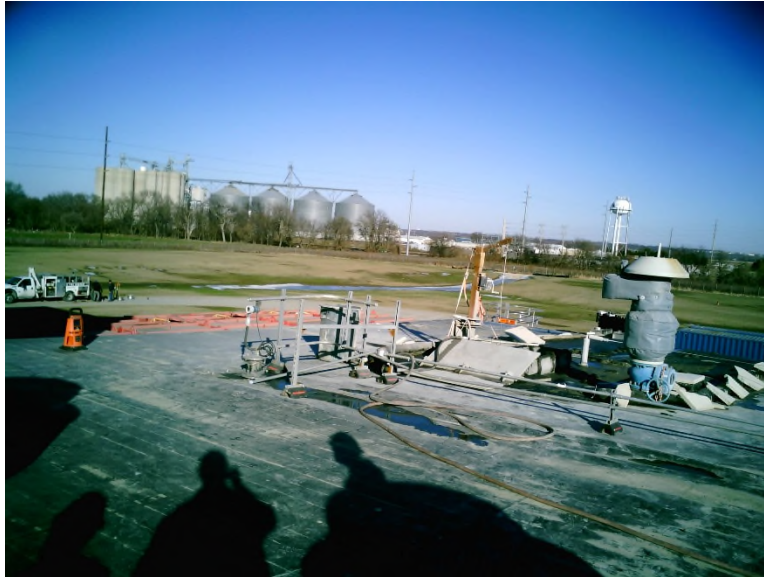
We observed repairs in progress on Mixer 1 of Digester 1, noting a hoist and open mixer port (see Attachment 3, Photograph 3). Ms. McCaslen said that she expected the mixer to be brought online soon.

<p>CASE NO. 18NE1113</p> <p>Direction: Northeast</p>	DESCRIPTION	This photograph shows an Industrial Scientific RADIUS-BZ1 gas monitor (left) and a hoist over a mixing port of Digester 1 being used to install a repaired mixer.	3
	FACILITY	Big Ox Energy - Siouxland, LLC	Date
	PHOTOGRAPHER	Dave Hensley	11/13/2018

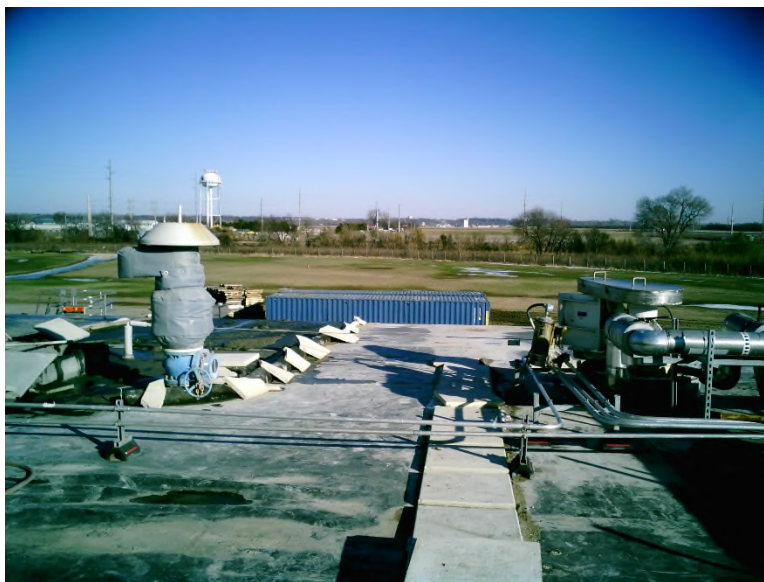
Ms. McCaslen told us that a foaming event/spill had occurred during the previous week. We observed closed roof hatches with cement blocks and other materials stacked on them, presumably to keep them closed during foaming events. We also observed some remnant solid waste material on the roof that appeared to be related to an overflow from the south hatch of Digester 1.

<p>CASE NO. 18NE1113</p> <p>Direction: East</p>	DESCRIPTION	This photograph shows a berm that has been constructed around a roof hatch of Digester 1 (left) to direct overflow material.	4
	FACILITY	Big Ox Energy - Siouxland, LLC	Date
	PHOTOGRAPHER	Dave Hensley	11/13/2018

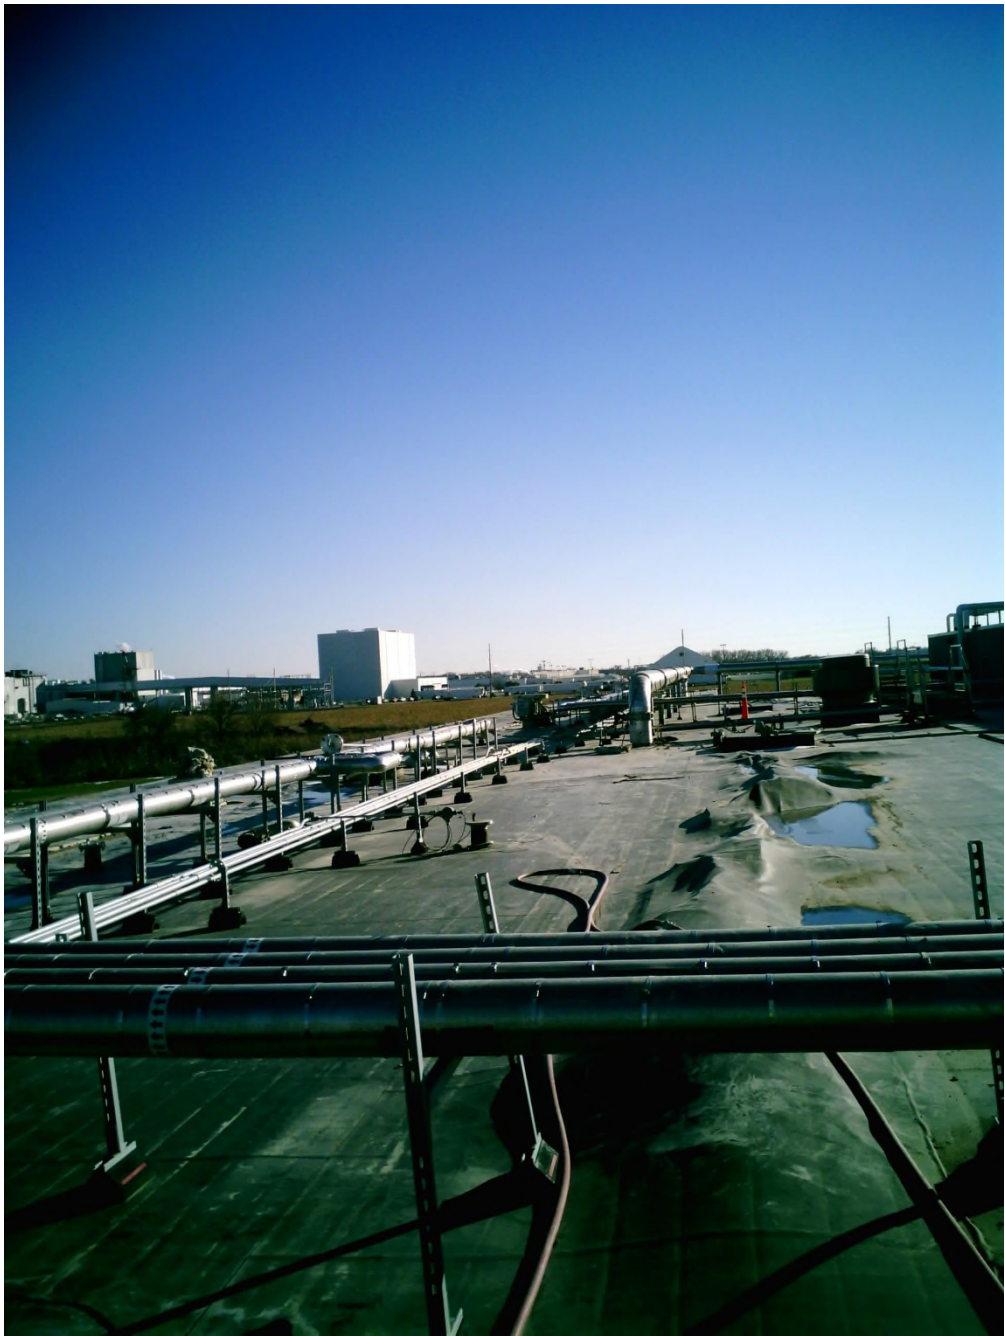
The reinforced concrete digester roofs are covered with black membrane material. Along the east edge of Digester 1, we observed that the membrane was raised in some areas (see Attachment 3, Photograph 5).

CASE NO. 18NE1113 Direction: South	DESCRIPTION	This photograph shows areas of the roof membrane that have raised (right). The raised areas appear to coincide with transition from the west edge of Digester 1 and the adjoining facility building.	5
	FACILITY	Big Ox Energy - Siouxland, LLC	Date
	PHOTOGRAPHER	Dave Hensley	11/13/2018

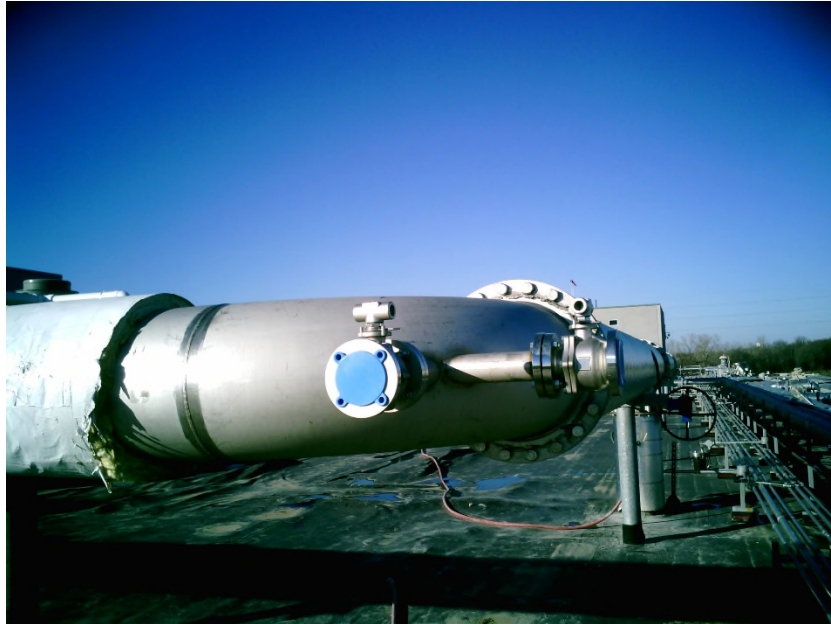
CASE NO. 18NE1113 Direction: North	DESCRIPTION	This photograph shows a gas sampling port over Digester 2.	6
	FACILITY	Big Ox Energy - Siouxland, LLC	Date 11/13/2018
	PHOTOGRAPHER	Dave Hensley

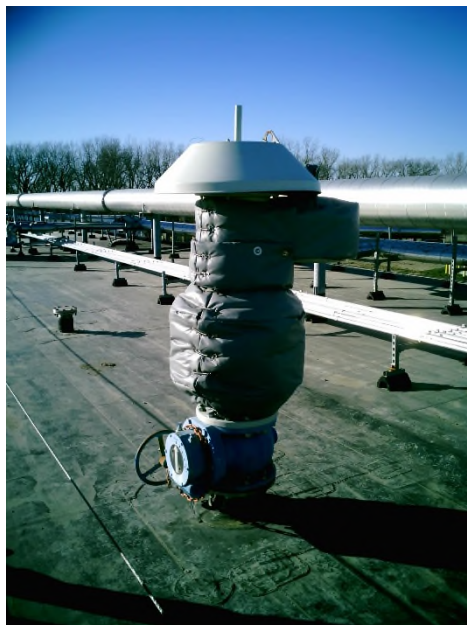
We observed several PRVs for the digesters. They are approximately 6 feet tall and release directly to the atmosphere (the PRVs are not equipped with any exhaust piping that would convey releases above the breathing zone of a person standing on the roof) (see Attachment 3, Photographs 4 and 7). A wind sock was on roof of the receiving bay.

CASE NO. 18NE1113 Direction: Northeast	DESCRIPTION	This photograph shows a pressure relieve valve (PRV) for Digester 2.	7
	FACILITY	Big Ox Energy - Siouxland, LLC	Date 11/13/2018
	PHOTOGRAPHER	Dave Hensley

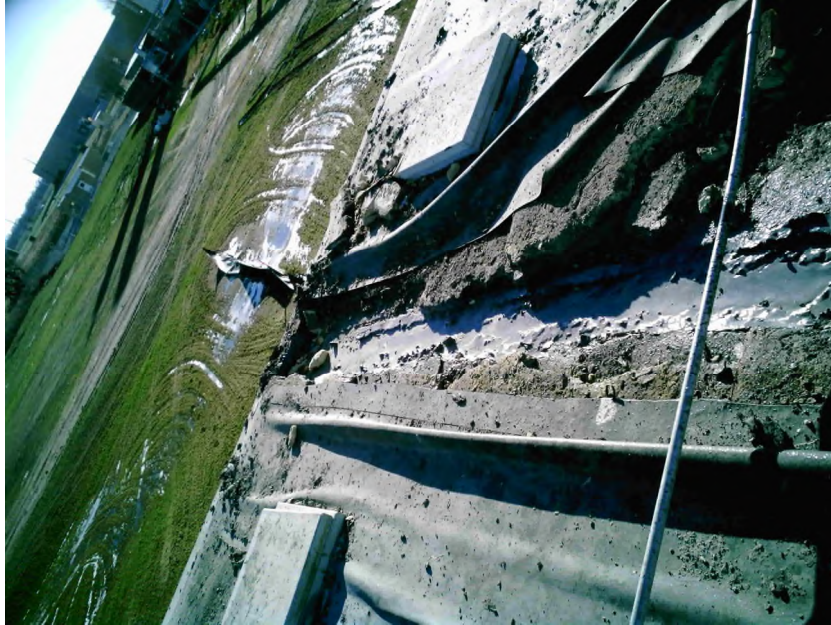
Ms. McCaslen showed us the easternmost expansion joint of Digester 2 that had been repaired. Mr. Hensley noted a small amount of vapor escaping the junction of the repair and the south wall. Ms. McCaslen told us that additional repair would be necessary (see Attachment 3, Photographs 8, 9, and 10).

CASE NO. 18NE1113 Direction: South	DESCRIPTION	This photograph shows a recently repaired expansion joint on the roof of Digester 2.	8
	FACILITY	Big Ox Energy - Siouxland, LLC	Date
	PHOTOGRAPHER	Dave Hensley	11/13/2018

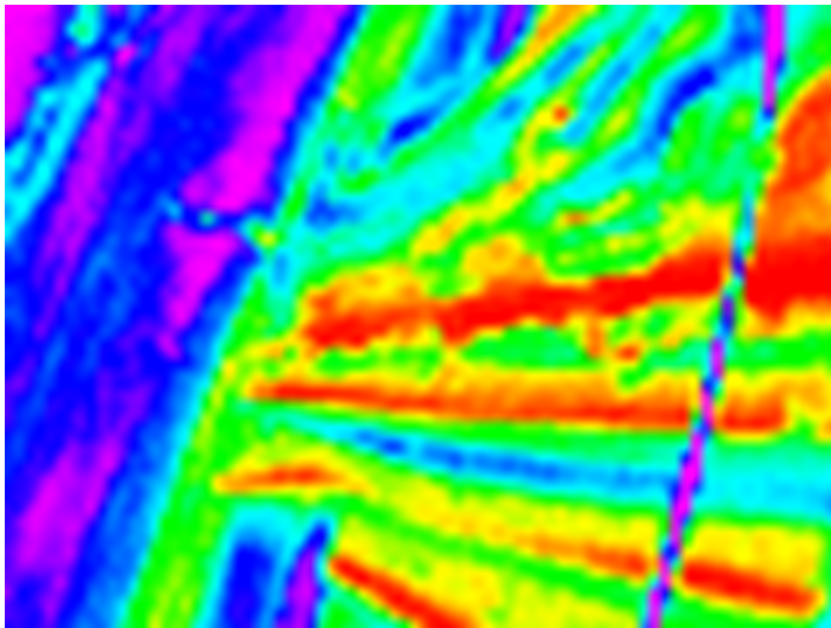
CASE NO. 18NE1113 Direction: South	DESCRIPTION	This photograph is a thermal image of the repair expansion joint shown in Photograph 8.	9
	FACILITY	Big Ox Energy - Siouxland, LLC	Date
	PHOTOGRAPHER	Dave Hensley	11/13/2018

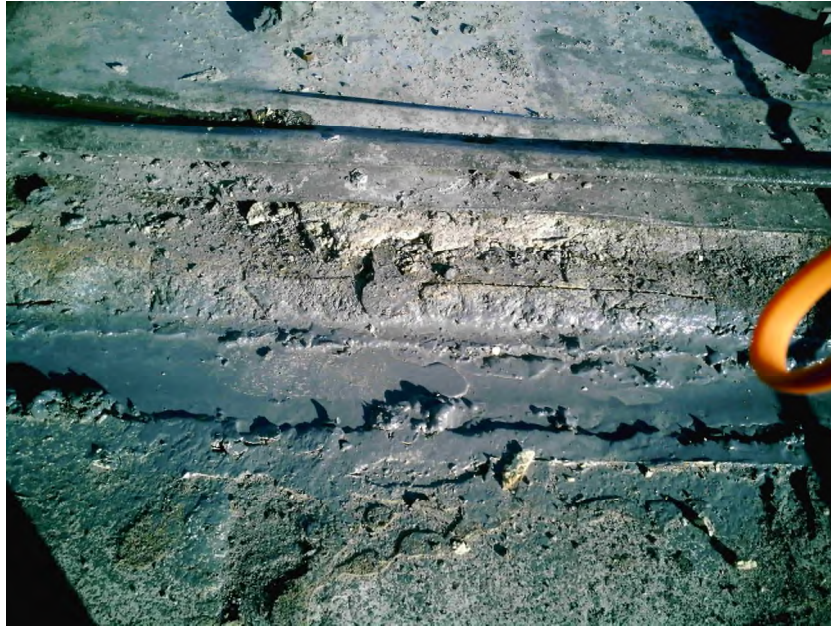
CASE NO. 18NE1113 Direction: N/A	DESCRIPTION	This photograph shows a repaired expansion joint on Digester 2.	10
	FACILITY	Big Ox Energy - Siouxland, LLC	Date
	PHOTOGRAPHER	Dave Hensley	11/13/2018

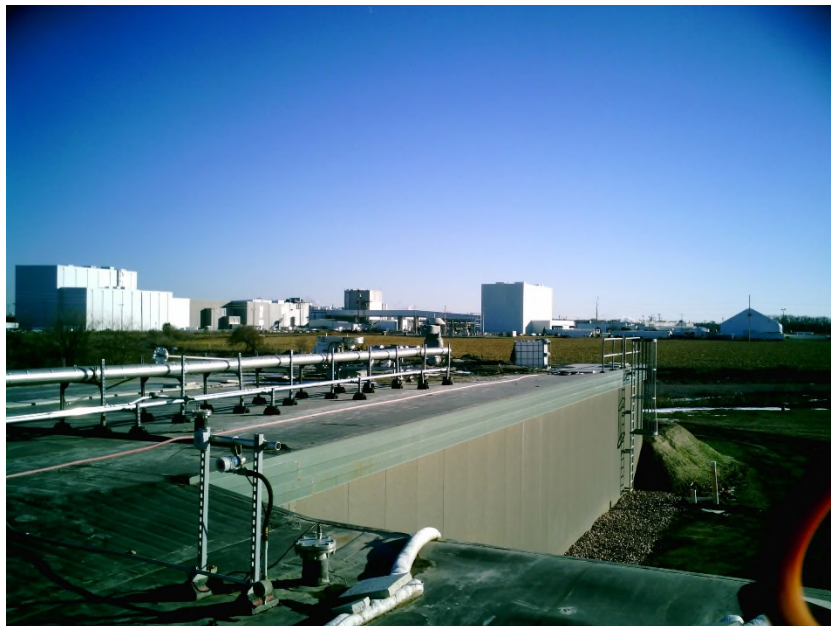
CASE NO. 18NE1113 Direction: Southeast	DESCRIPTION	This photograph shows the south end of Digester 1 and an earthen containment structure that has been constructed on the ground surface at the south end of Digester 1 (right).	11
	FACILITY	Big Ox Energy - Siouxland, LLC	Date
	PHOTOGRAPHER	Dave Hensley	11/13/2018

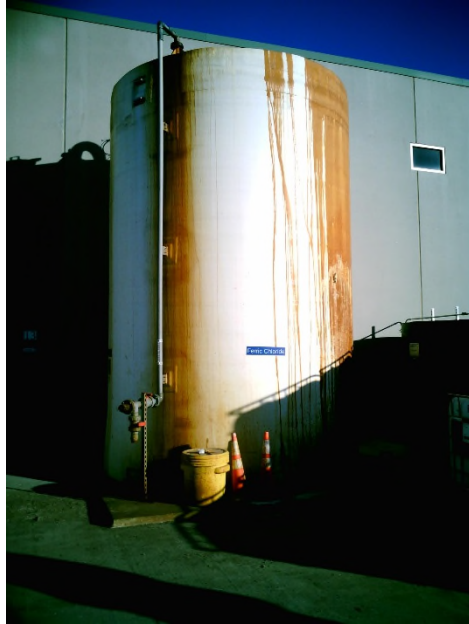
CASE NO. 18NE1113 Direction: East	DESCRIPTION	This photograph shows a ferric chloride tank with staining from a tank overfill event.	12
	FACILITY	Big Ox Energy - Siouxland, LLC	Date
	PHOTOGRAPHER	Dave Hensley	11/13/2018

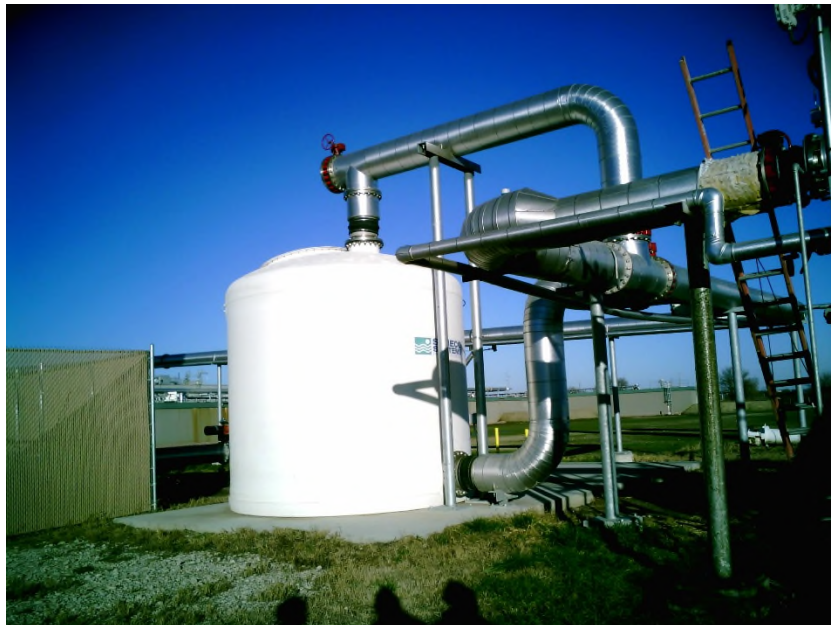
CASE NO. 18NE1113 Direction: Northeast	DESCRIPTION	This photograph shows a hydrogen sulfide scrubber at the biogas skid.	13
	FACILITY	Big Ox Energy - Siouxland, LLC	Date
	PHOTOGRAPHER	Dave Hensley	11/13/2018

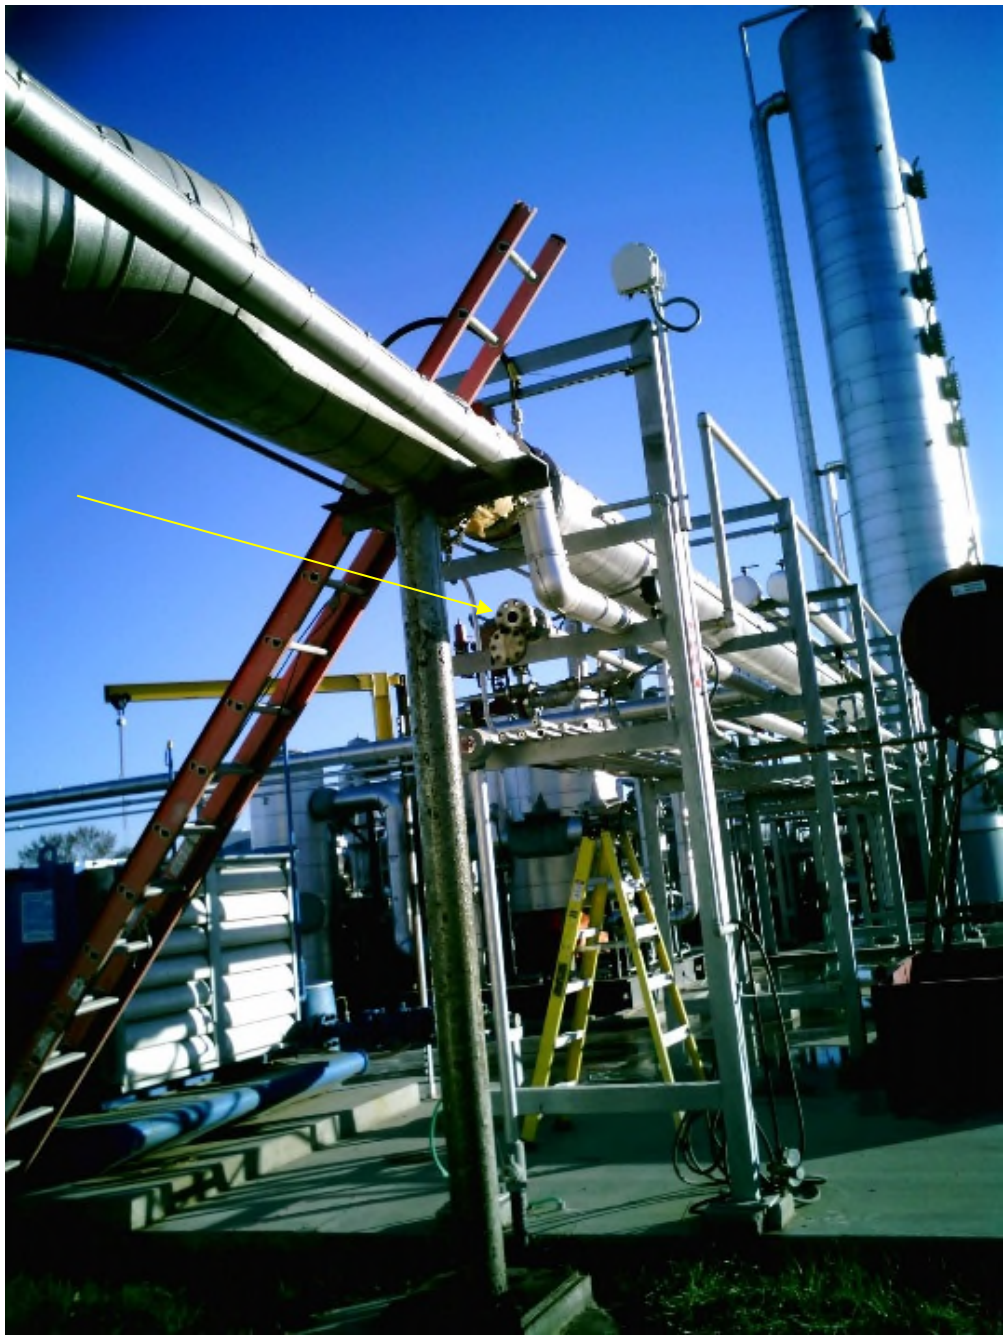
CASE NO. 18NE1113 Direction: South	DESCRIPTION	This photograph shows a portion of the biogas skid. A carbon dioxide scrubber tower is in the background (right). The arrow indicates the bypass exhaust port.	14
	FACILITY	Big Ox Energy - Siouxland, LLC	Date
	PHOTOGRAPHER	Dave Hensley	11/13/2018
